**CITY OF NAPOLEON  
BUILDING CONSTRUCTION PERMIT**

Building Permit No.: As listed Location: Riviera Heights

Watson Builders @ Riviera Heights, Corinne Hurni, Owner.

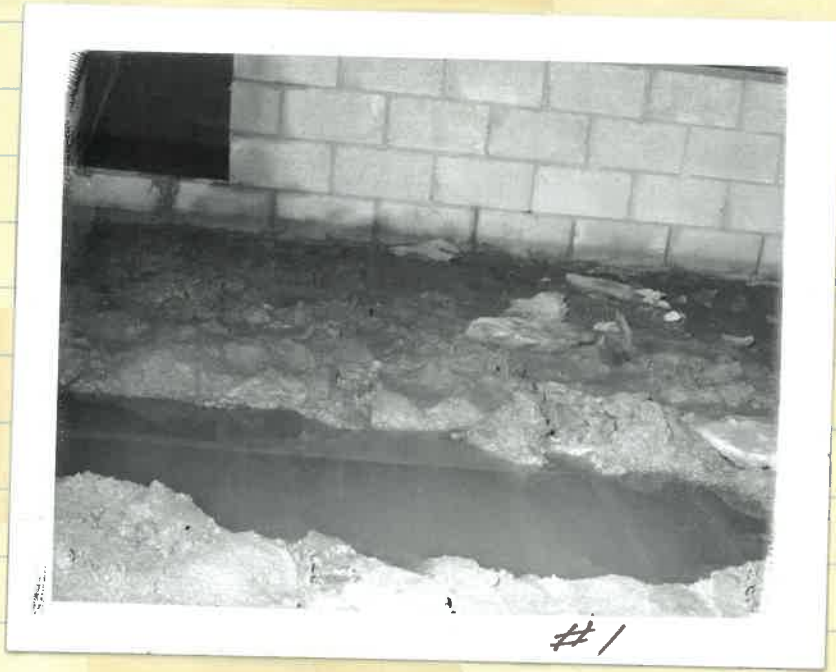
Bldg Permit #117-73

The very wet ground conditions in the crawl space, no ventilation openings provided, no provision installed to control this condition

Photo # 1 ~ The very wet ground condition in the crawl space, no ventilation provided, no provisions installed for controlling this condition.

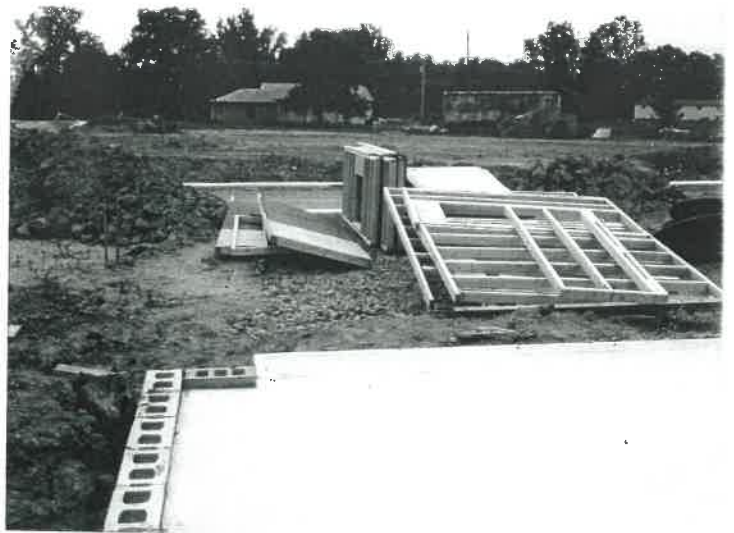
#8

Photo # 8 - The typical method of  
storing construction material on  
the job site, unprotected and poorly  
placed.

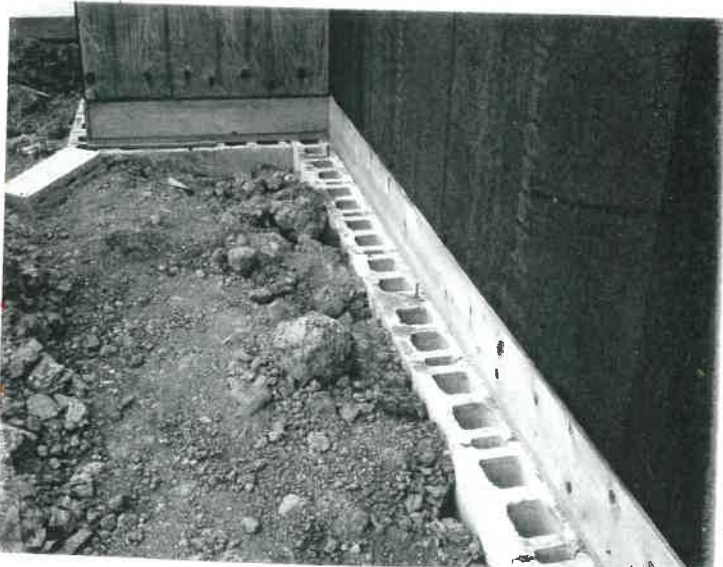
#3

Photo # 3 ~ The frame of the new home mat on top of the foundation wall.

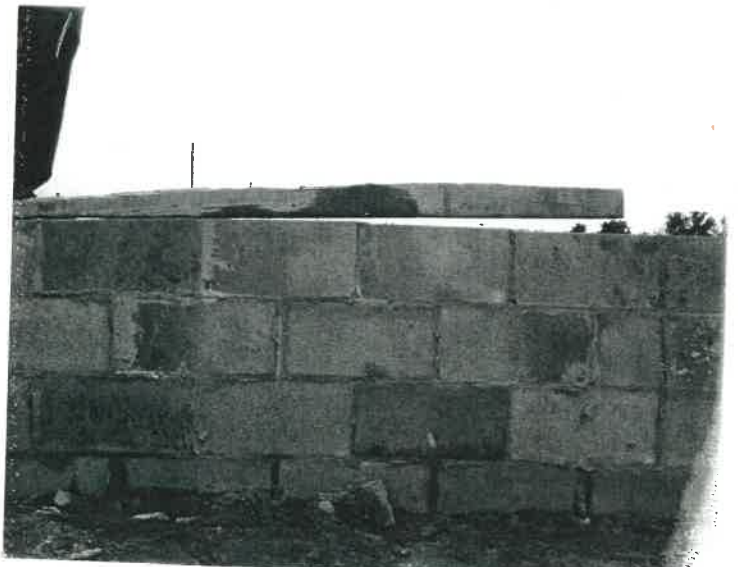
#9

Photo # 9, This wall was complete relaid.  
note the ~~bottom edge of the~~ the  
~~the~~ vertical uniformity.
