Subject: Complaint issued by Mrs. Mary Sauber at  
204 Filmore St. for possible violation  
of City Ordinance No. 464 at 202 Filmore  
St.

The subject residence was inspected by me on January 27,  
1975 and the following facts were evident:

Thomas W. Terranova  
City Building Inspector  
Engineering Department

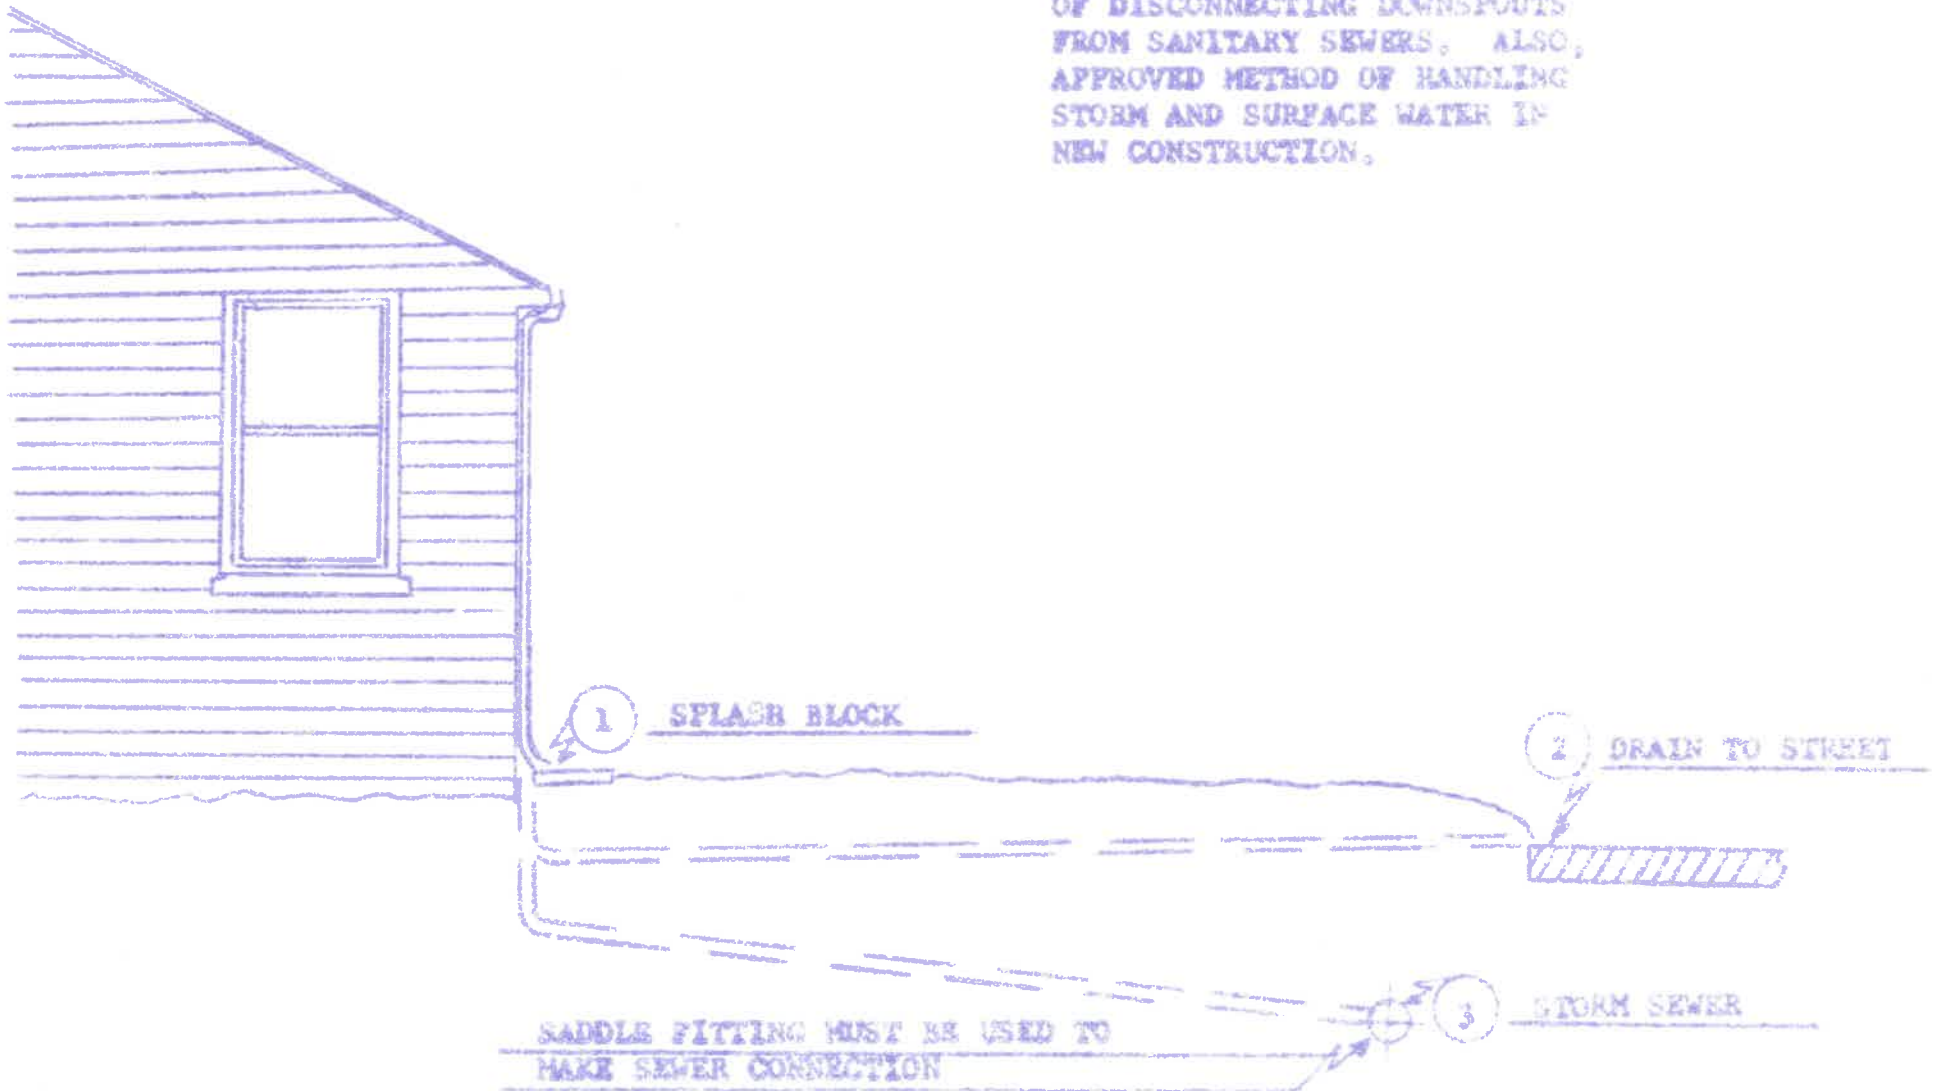
SKETCH SHOWING  
THREE APPROVED METHODS  
OF DISCONNECTING DOWNSPOUTS  
FROM SANITARY SEWERS. ALSO,  
APPROVED METHOD OF HANDLING  
STORM AND SURFACE WATER IN  
NEW CONSTRUCTION.

1. On the Northeastern side of the dwelling, the down-  
spout is not properly installed to handle water  
drainage.
2. The present installation is also a hazardous con-  
dition because of its location near a means of  
egress in case of a fire.

Therefore, you must comply with any one of the three  
approved methods noted on the attached sketch within fourteen  
(14) days from the date of this notice or the City of Napoleon  
will have no other alternative but to enforce the penalties  
set forth in Section 6 and 7 of City Ordinance No. 464.
