3-8-18  
L.J. Irving  
Fire Damage Demo

1010 S. PERRY ST.  
HOUSE THAT BURNED

Pipe Graphic Report of PLR S 120 X for Napoleon

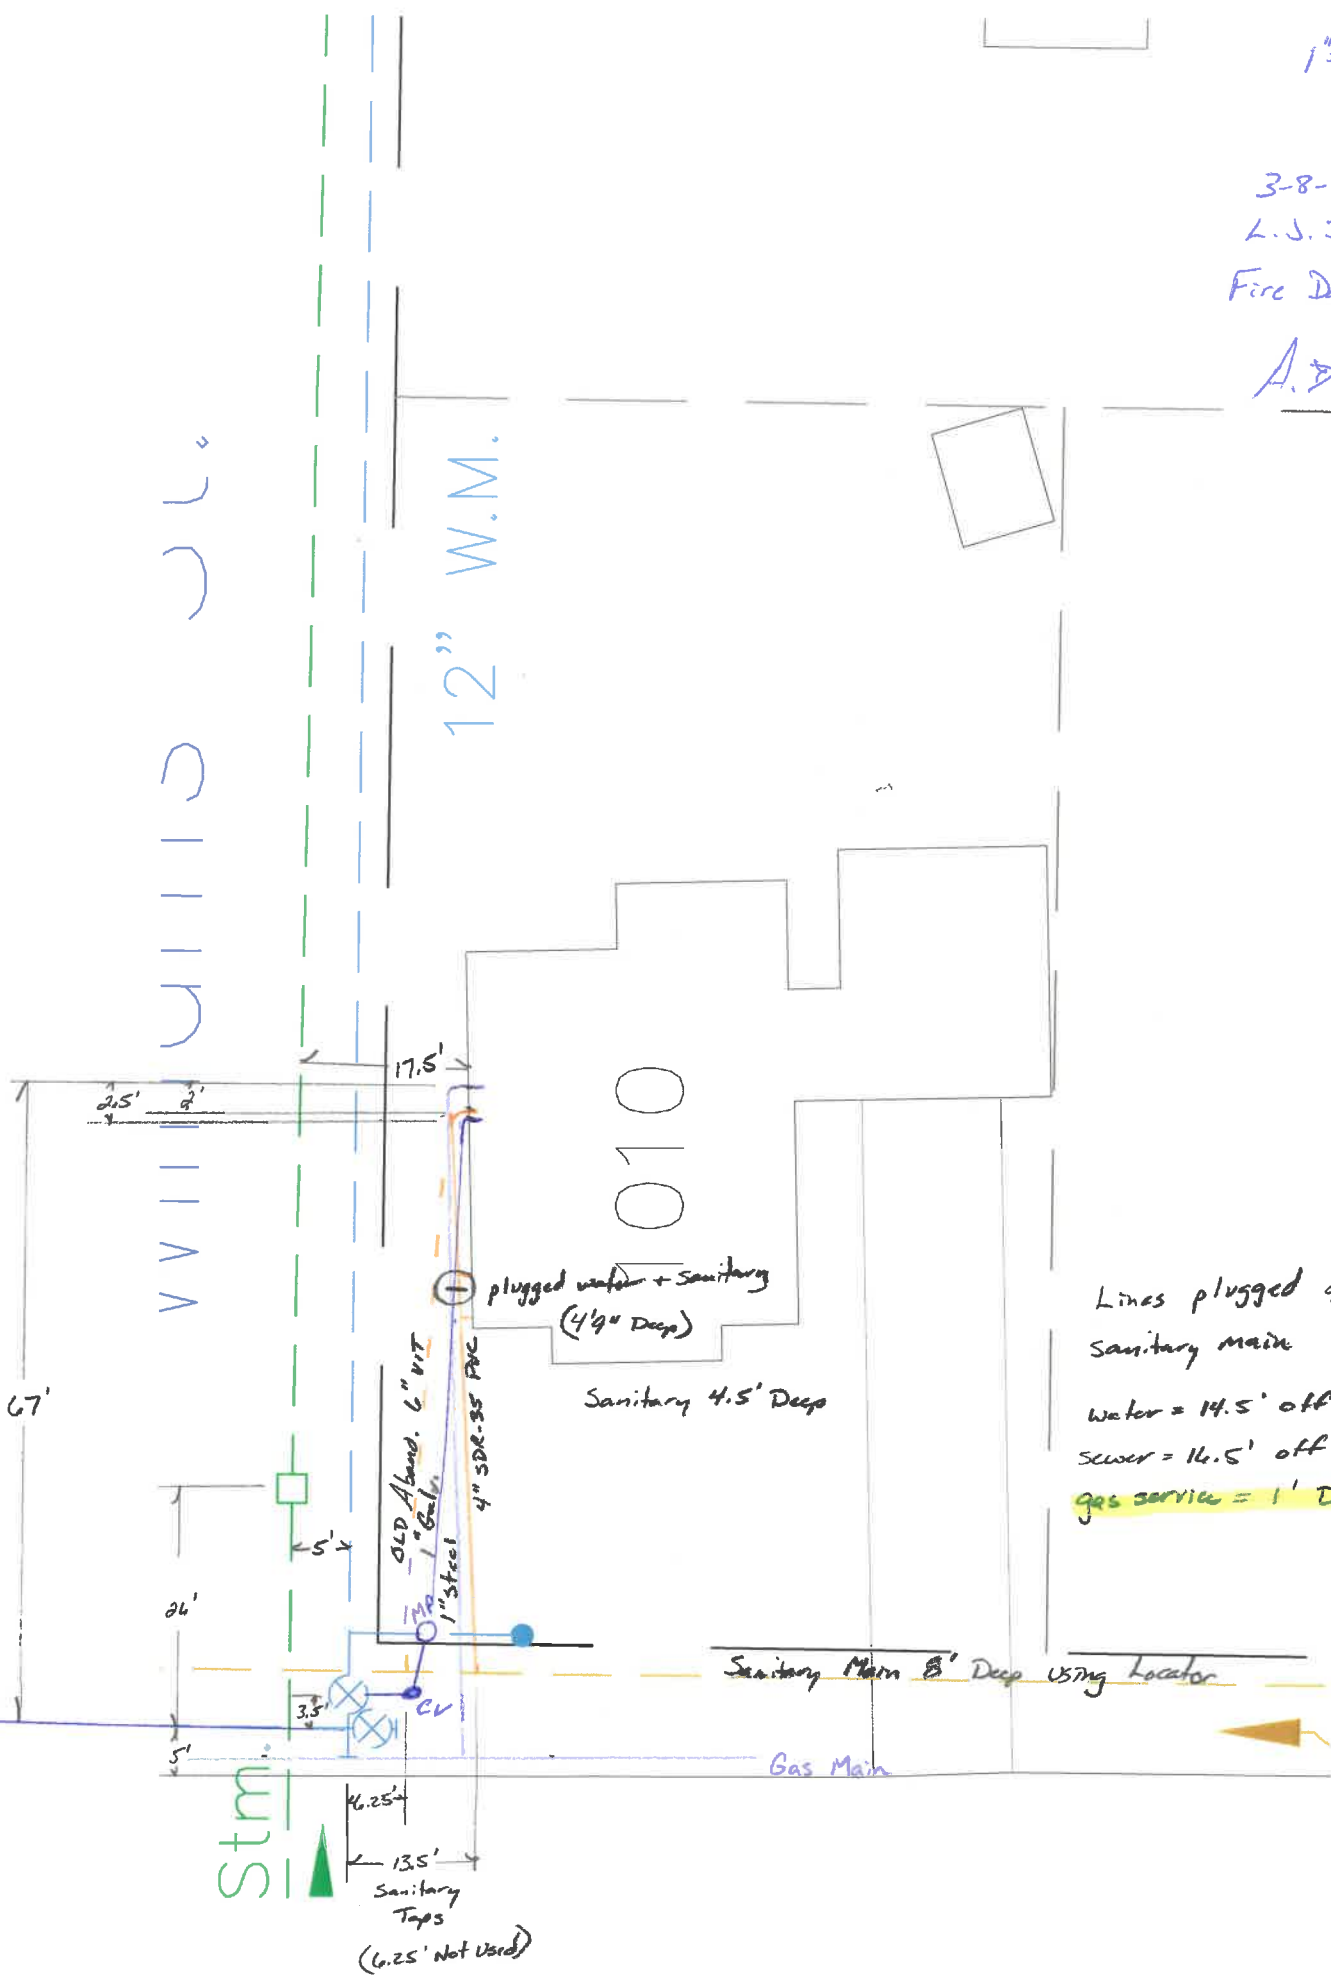
Lines plugged 40'4" from  
Sanitary main  
 Water = 14.5' off storm main  
 Sewer = 16.5' off storm main  
 Gas service = 1' Deep by house

Sanitary Taps  
(6.25' Not Used)
