WAYNE PARK DR.
 CONTI: JERRY HILLIS
 INSP: MARK SPIESS
 JULY 2015

WAYNE PARK DR.
CONT: JERRY HILLIS
INSP: MARK SPIESS
JULY 2015

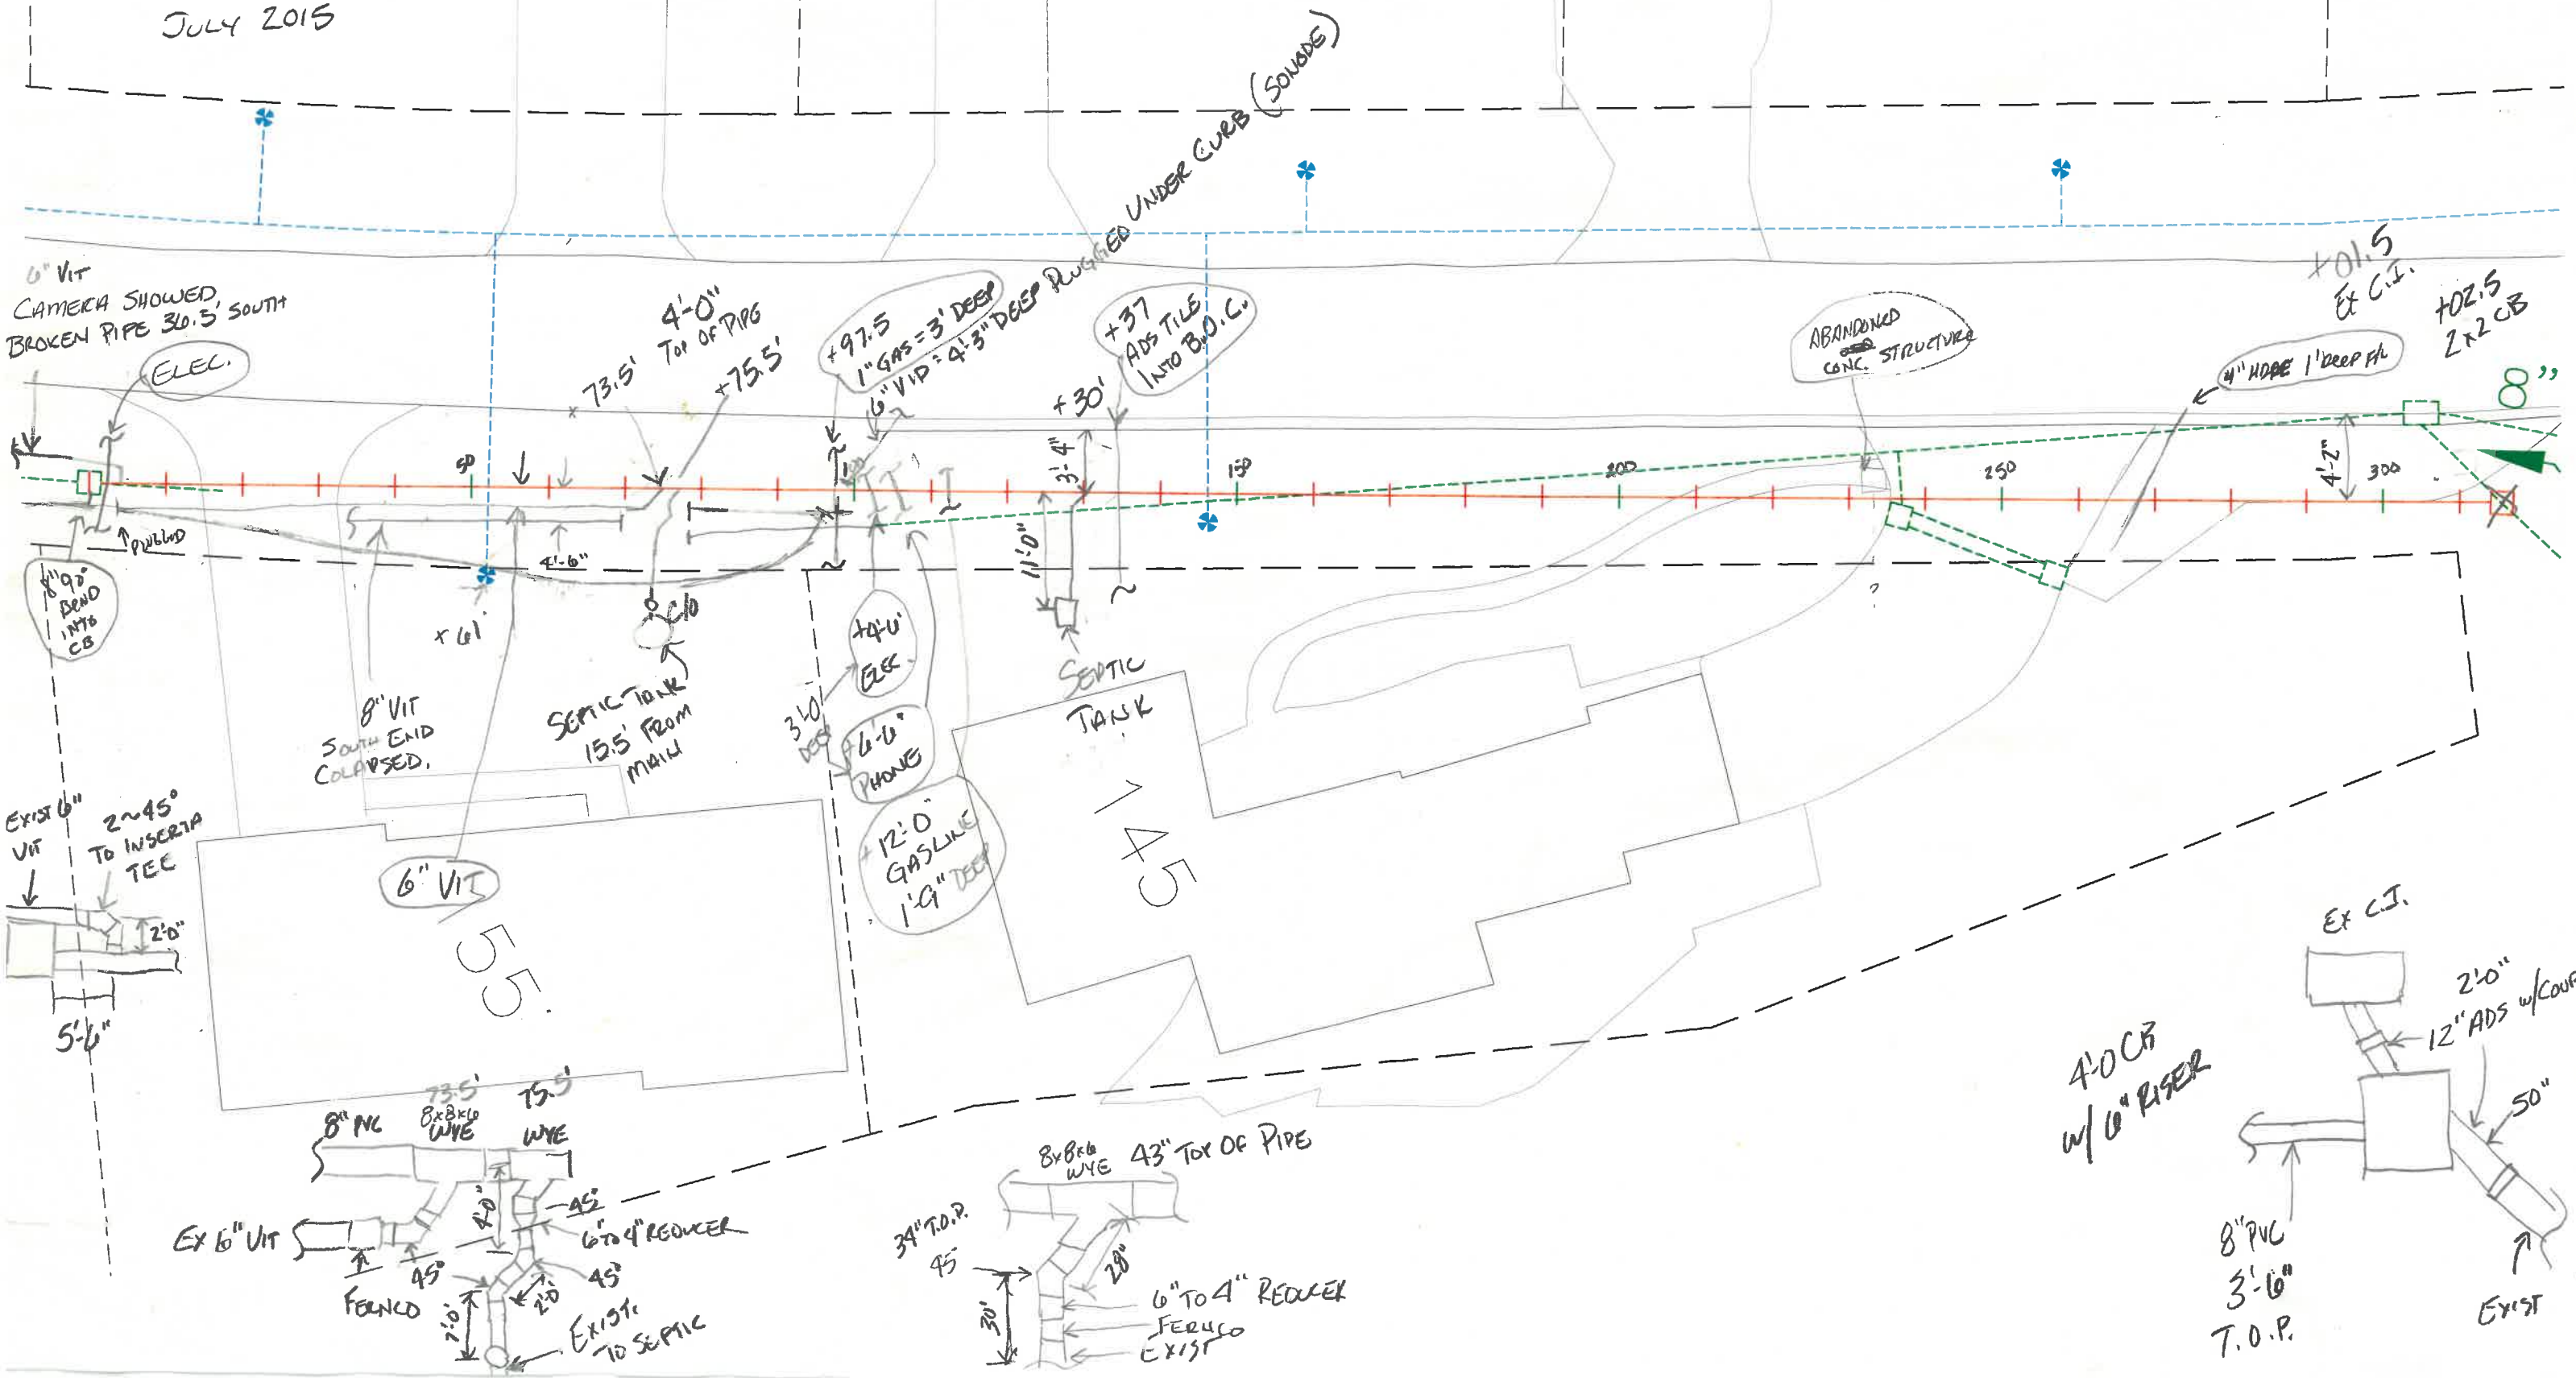
6" VIT
 CAMERA SHOWED
 BROKEN PIPE 30.5' SOUTH
 (ELEC.)

8" VIT
 SOUTH END
 COLLAPSED.
 SEPTIC TANK
 15.5' FROM
 MAIN

EXIST 6" VIT
 2~45° TO INSERT A TEE
 2'-0"
 5'-6"

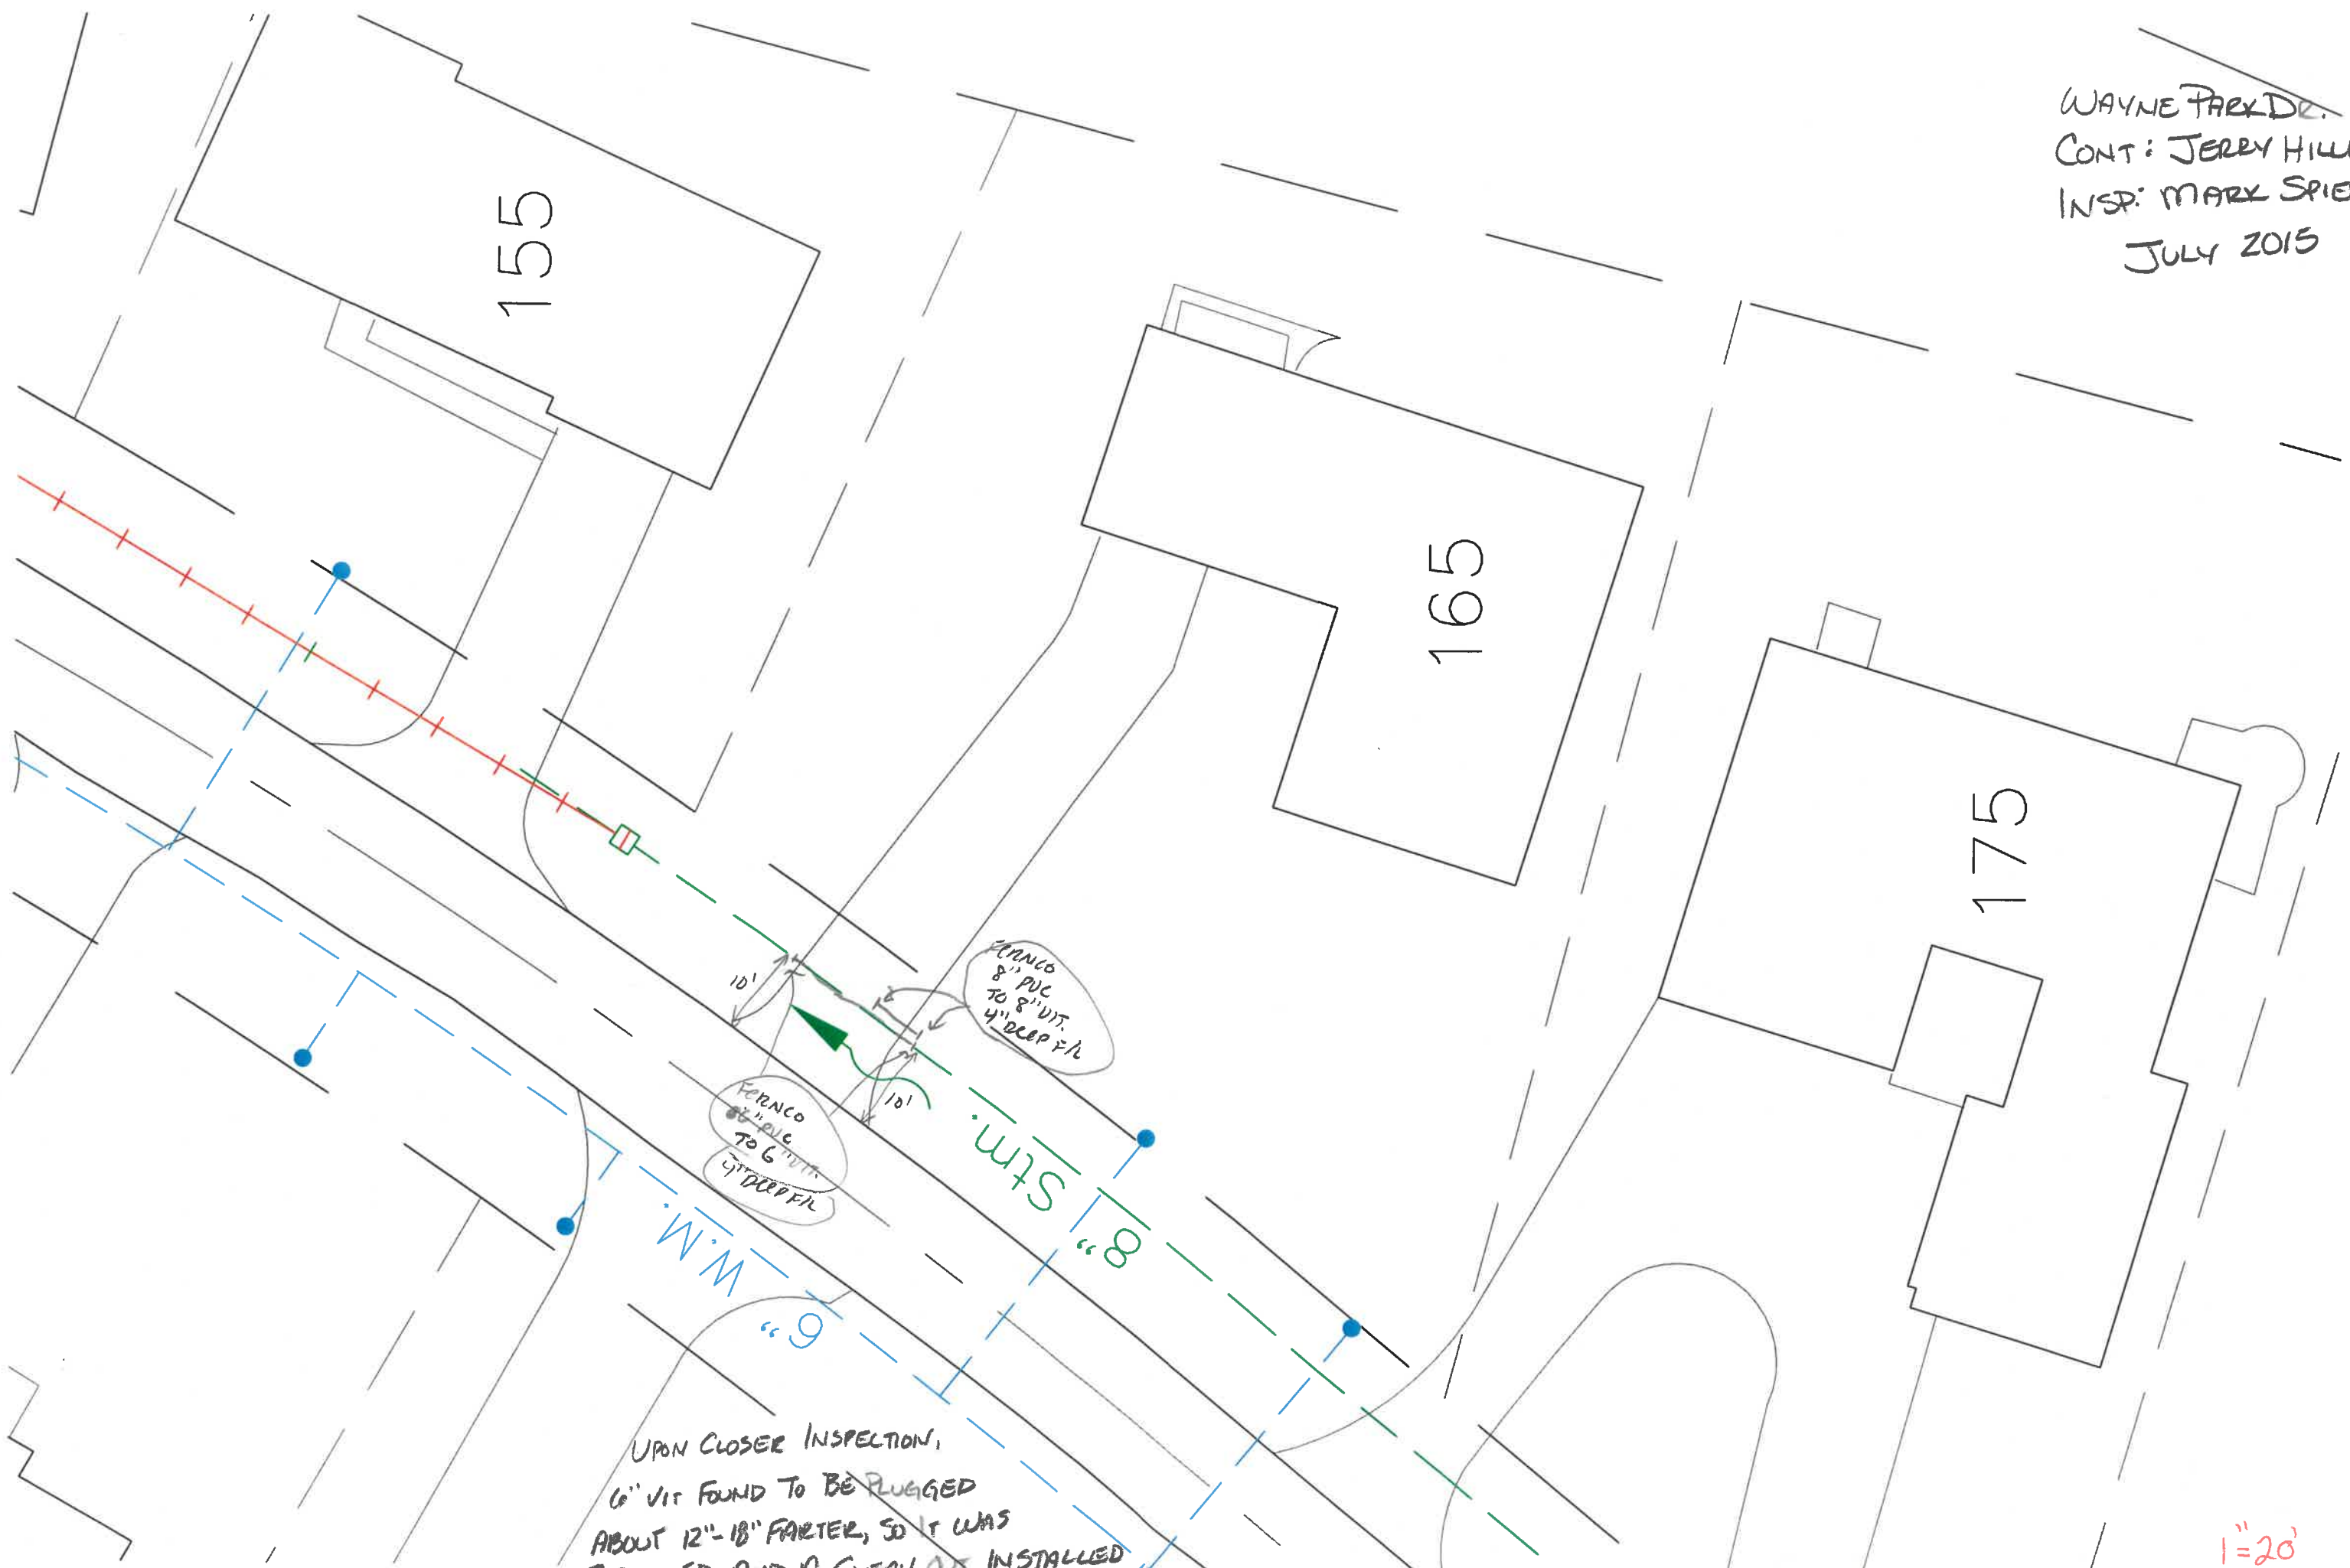
UPON CLOSER INSPECTION,
6" VIT FOUND TO BE PLUGGED
ABOUT 12"-18" FARTER, SO IT WAS
REMOVED AND A CLEAN OUT INSTALLED
