155 WAYNE PARK DR.

CONT.: JERRY HILLIS

INSP.: MARK SPIESS

JULY 2015

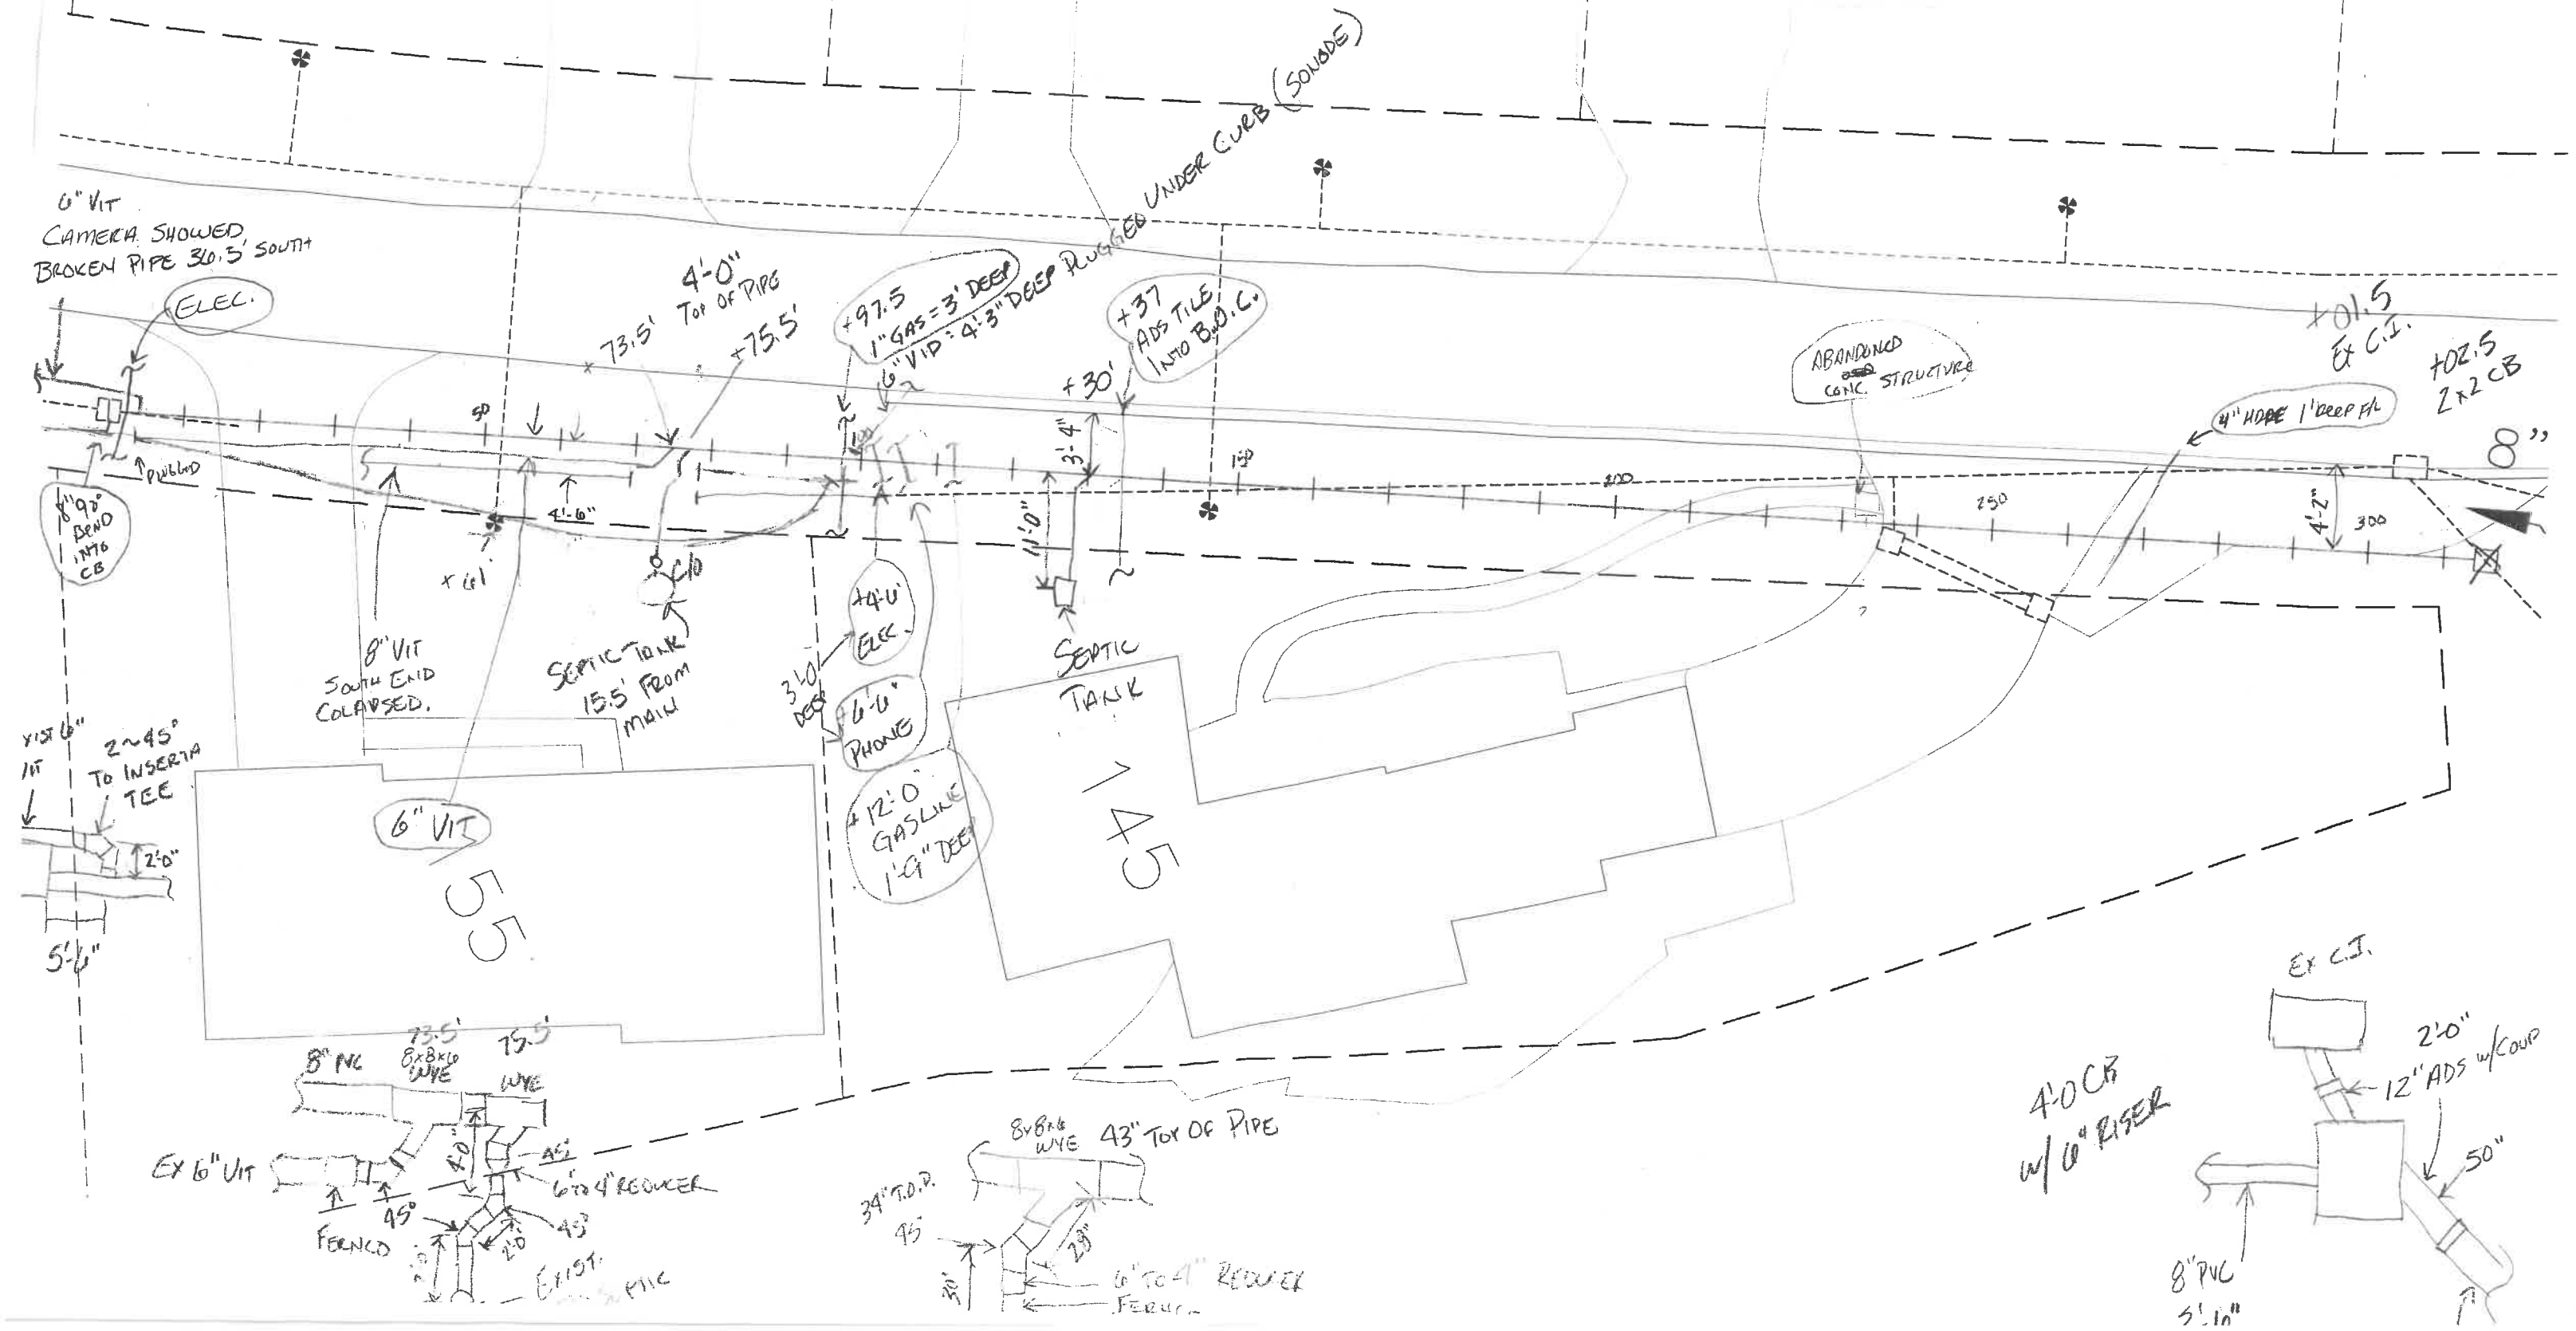
6" VIT  
CAMERA SHOWED  
BROKEN PIPE 30.5' SOUTH

UNDER CURB (SOUND)

ABANDONED  
CONC. STRUCTURE

+97.5  
1" GAS = 3' DEEP  
6" VIT = 4'-3" DEEP  
RUGHED

+37  
ABS TILE INTO B.O.C.

8" VIT SOUTH END COLLAPSED.

SEPTIC TANK 15.5' FROM MAIN

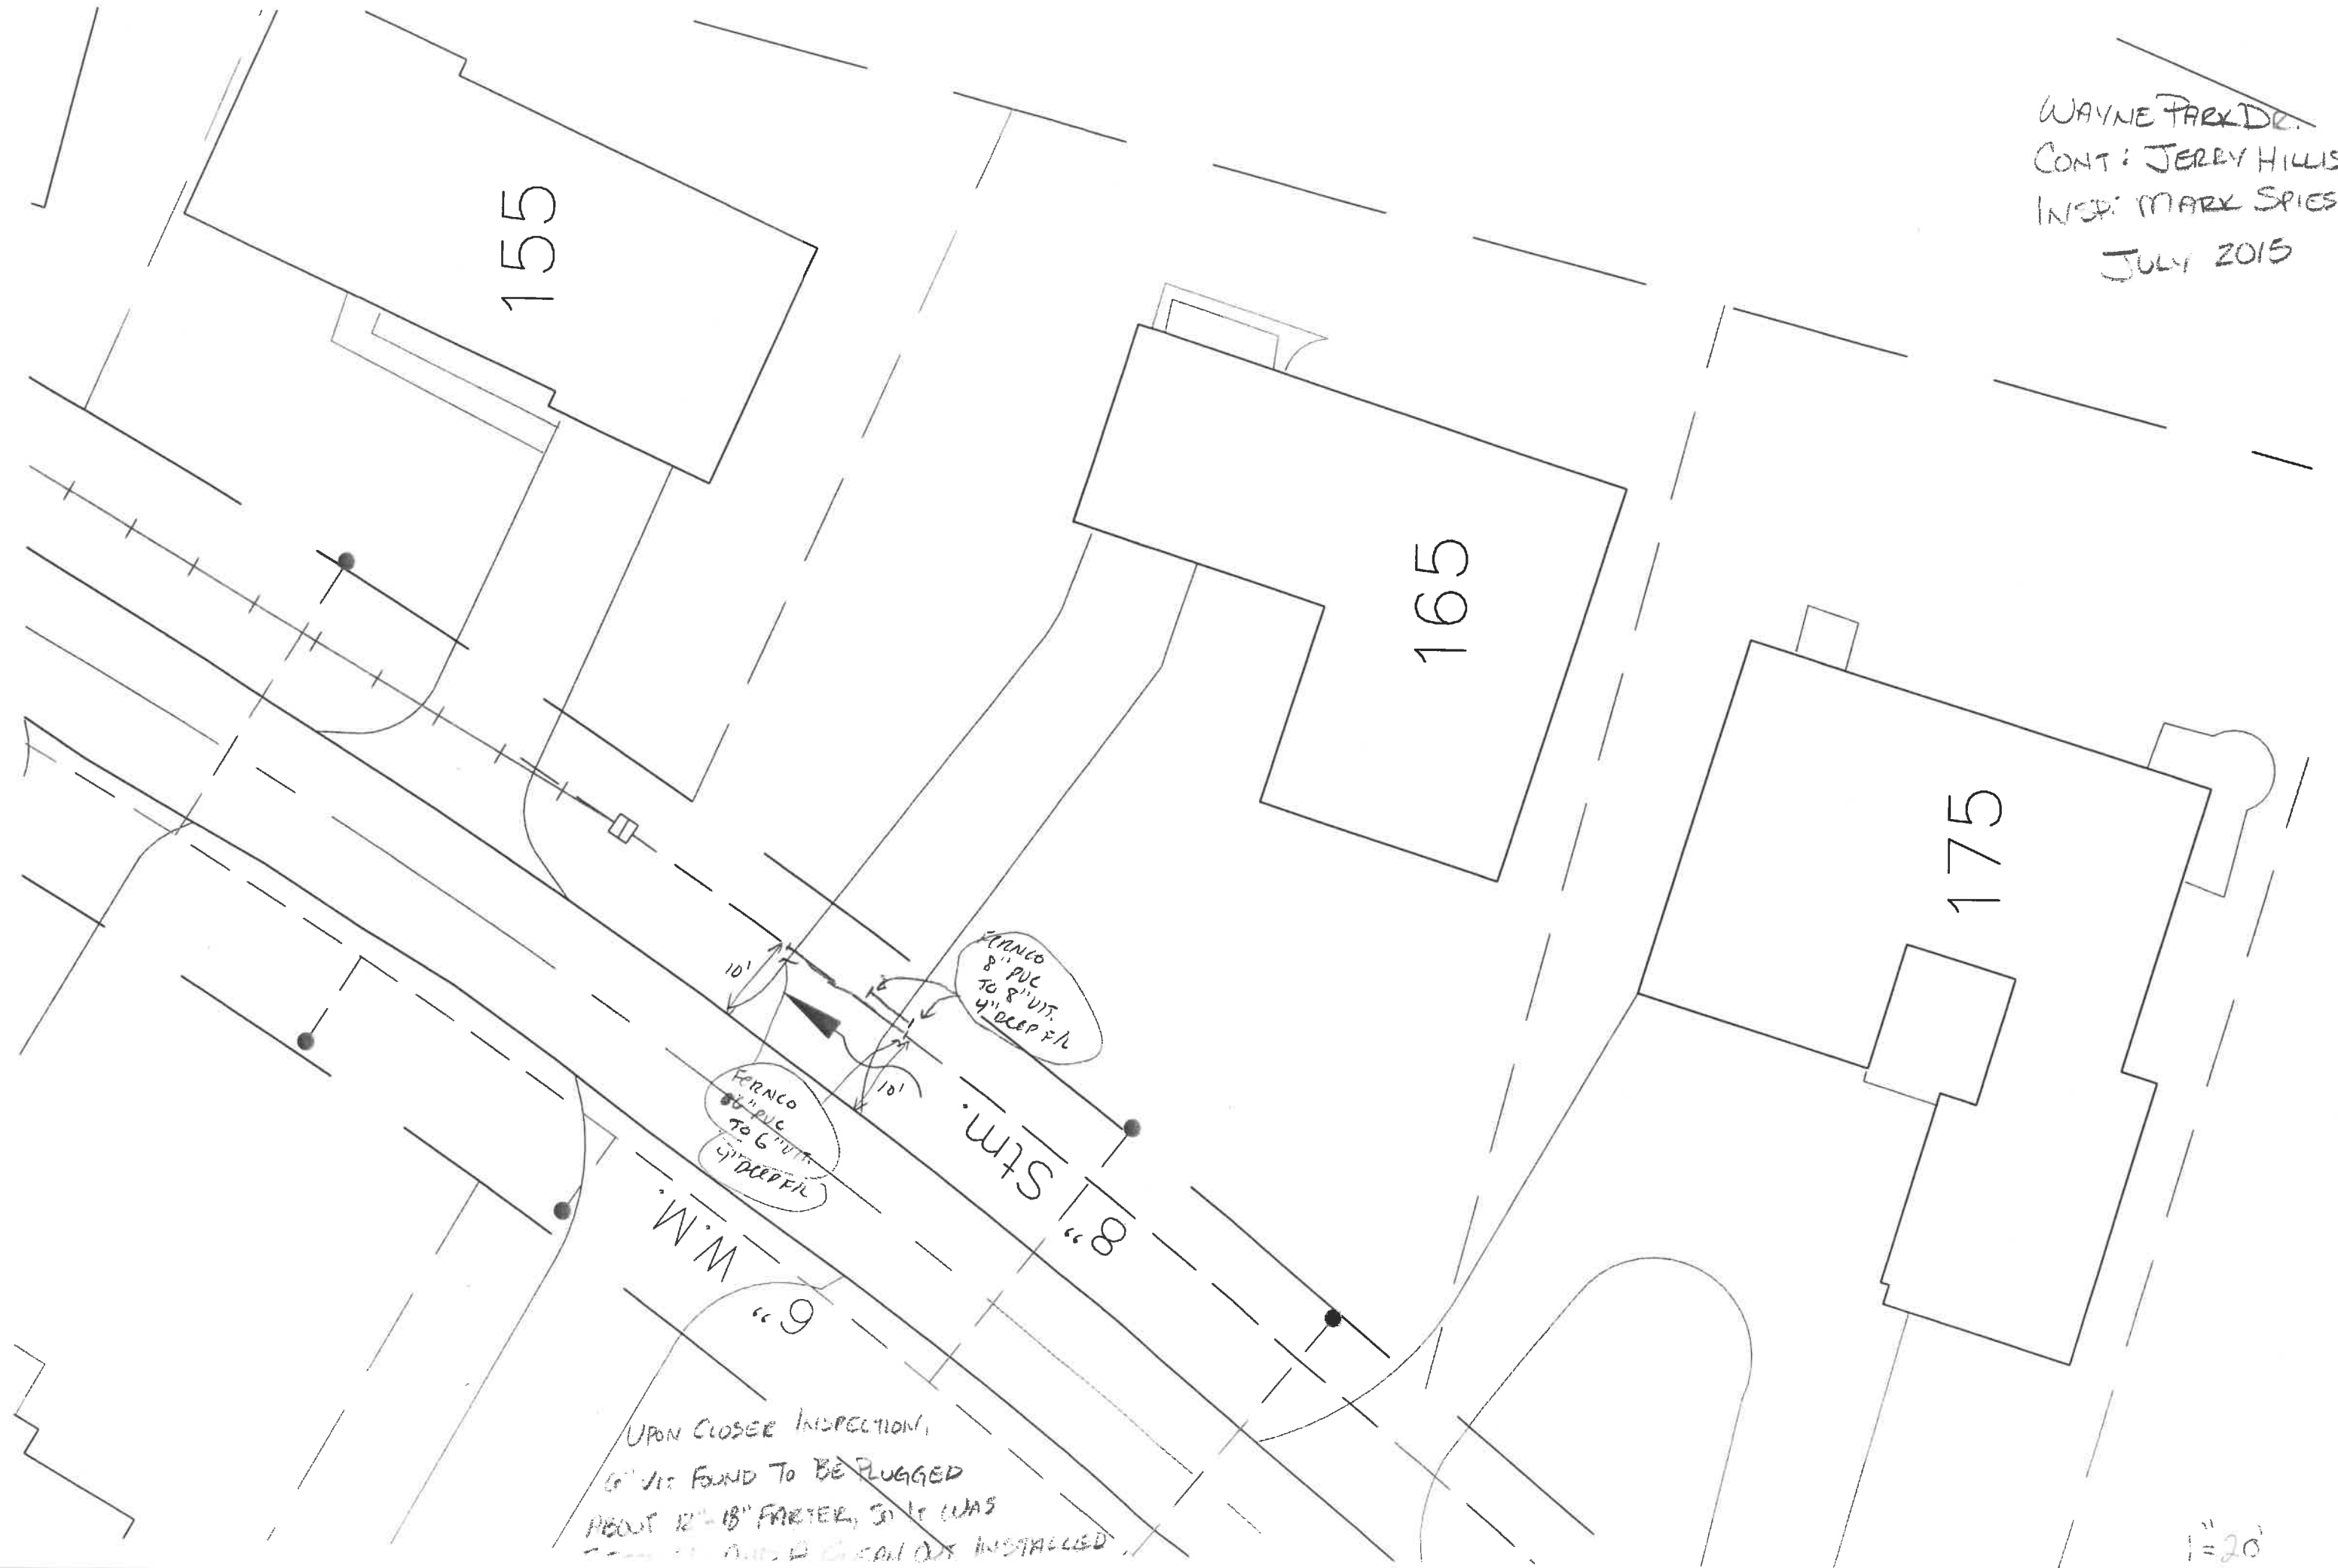
WAYNE PARK DR.  
CONT: JERRY HILLIS  
INSP: MARK SPIESS  
JULY 2015

UPON CLOSER INSPECTION,  
6" VJ FOUND TO BE PLUGGED  
ABOUT 12" B' FARTER, SO IT WAS  
REMOVED AND A 12" B' FARTER INSTALLED
