2015

1007 Scott Street

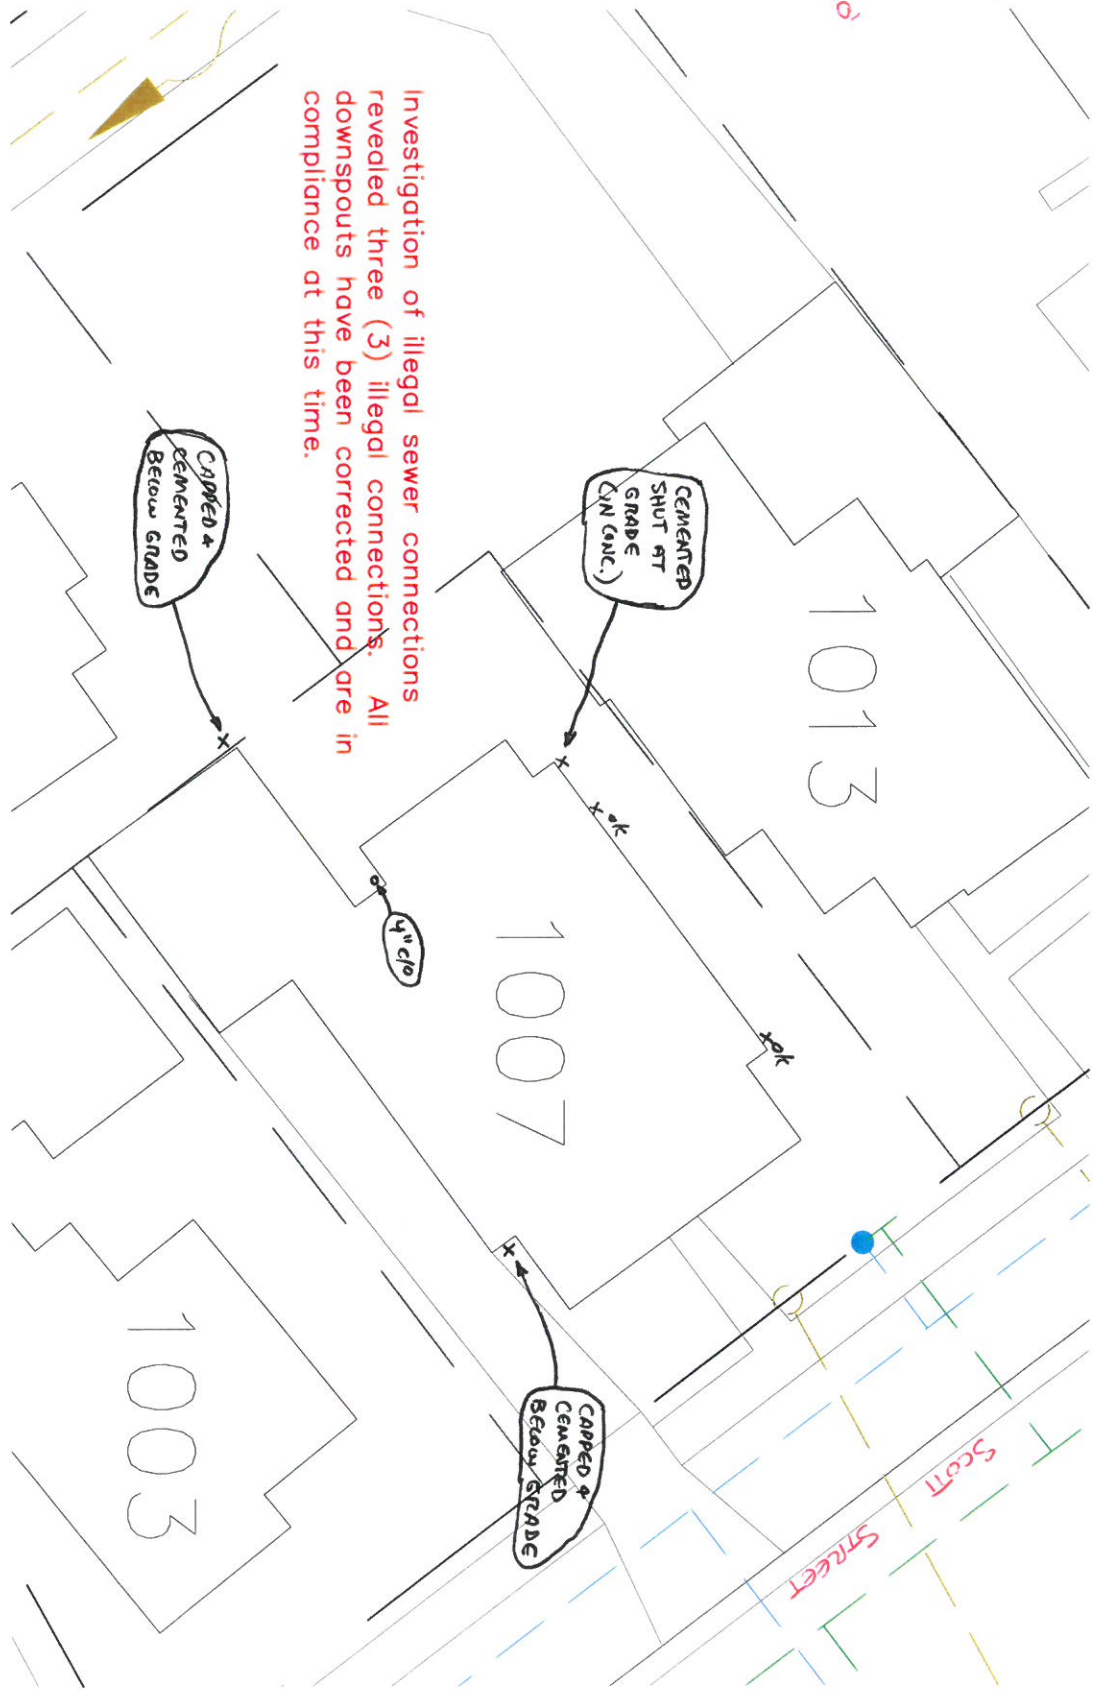
Investigation of illegal sewer connections revealed three (3) illegal connections. All downspouts have been corrected and are in compliance at this time.

CAPPED &
CEMENTED
BELOW GRADE

CEMENTED
SHUT AT
GRADE
(IN CONC.)
