**CITY OF NAPOLEON  
BUILDING CONSTRUCTION PERMIT**

Building Permit No.: As listed Location: Riviera Heights

Watson Builders @ Riviera Heights, Corinne Hurni, Owner.

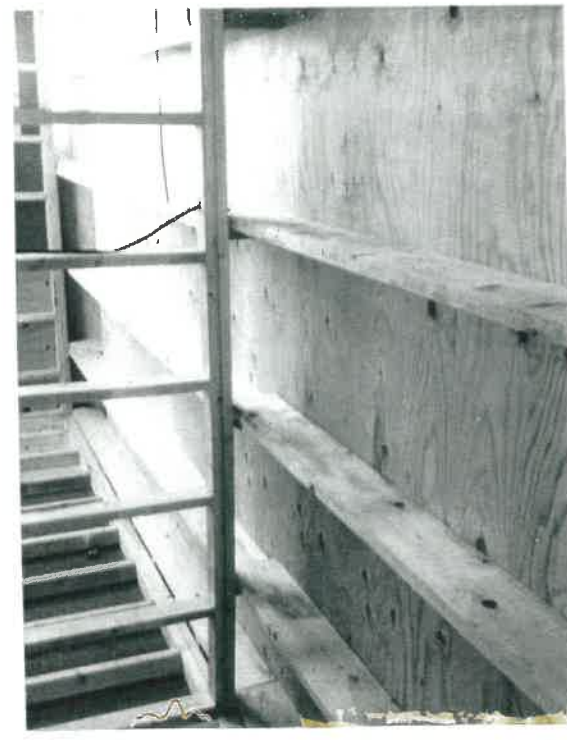
Lot 8

1. Only double 2x12 header over garage door ext.
2. Violation on min. distance of splice on top plates, example ext. garage wall. Gen. Conditions
3. ~~Single top plate on bearing partition on wall to right going down into lower level.~~ Corrected 8/29/74 P.W.P.
4. ~~Lower level improperly installed door headers joining into utility Rm & bath Rm.~~ Corrected 8/29/74 P.W.P.
5. 1/2" pipe on waste line for washing machine 2" required.
7. ~~Header directly above stairwell no support, carrying 4 roof truss 2x10 on center.~~ Corrected 9/12/74 P.W.P.
8. ~~Crawl space vents missing~~ corrected 9/12/74 P.W.P.
