Subject: Complaint issued by Mrs. Mary Sauber at  
204 Filmore St. for possible violation  
of City Ordinance No. 464 at 202 Filmore  
St.

The subject residence was inspected by me on January 27,  
1975 and the following facts were evident:

Thomas W. Terranova  
City Building Inspector  
Engineering Department

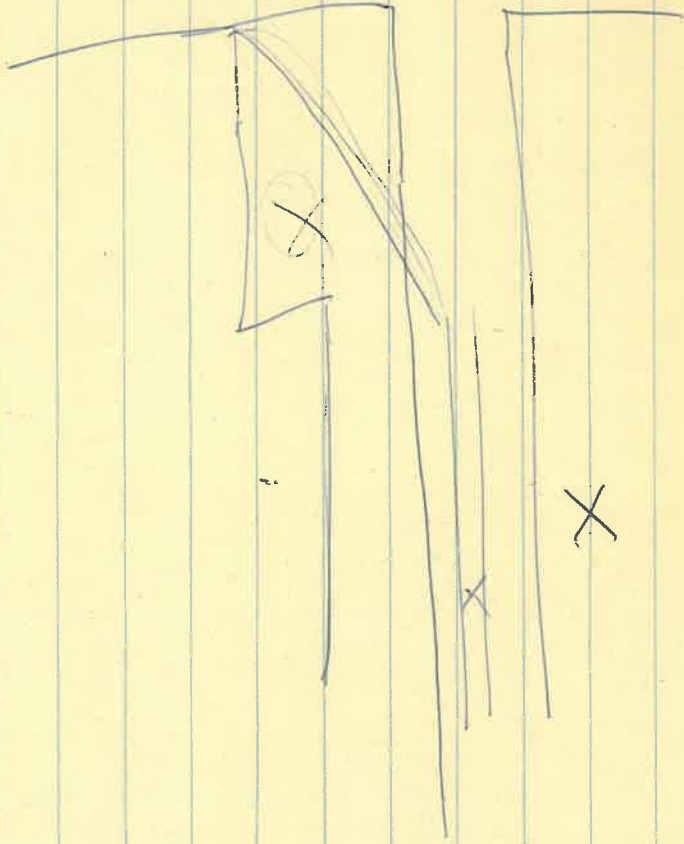
1. On the Northeastern side of the dwelling, the down-  
spout is not properly installed to handle water  
drainage.
2. The present installation is also a hazardous con-  
dition because of its location near a means of  
egress in case of a fire.

Therefore, you must comply with any one of the three  
approved methods noted on the attached sketch within fourteen  
(14) days from the date of this notice or the City of Napoleon  
will have no other alternative but to enforce the penalties  
set forth in Section 6 and 7 of City Ordinance No. 464.

Mr. Wenner changed routing  
of downspouts on week-in of  
1/25/75.
