DATE: 2013
INVESTIGATED BY CITY OF NAPLES
SEWER DEPT.
1000 W. RIVERVIEW
SANITARY

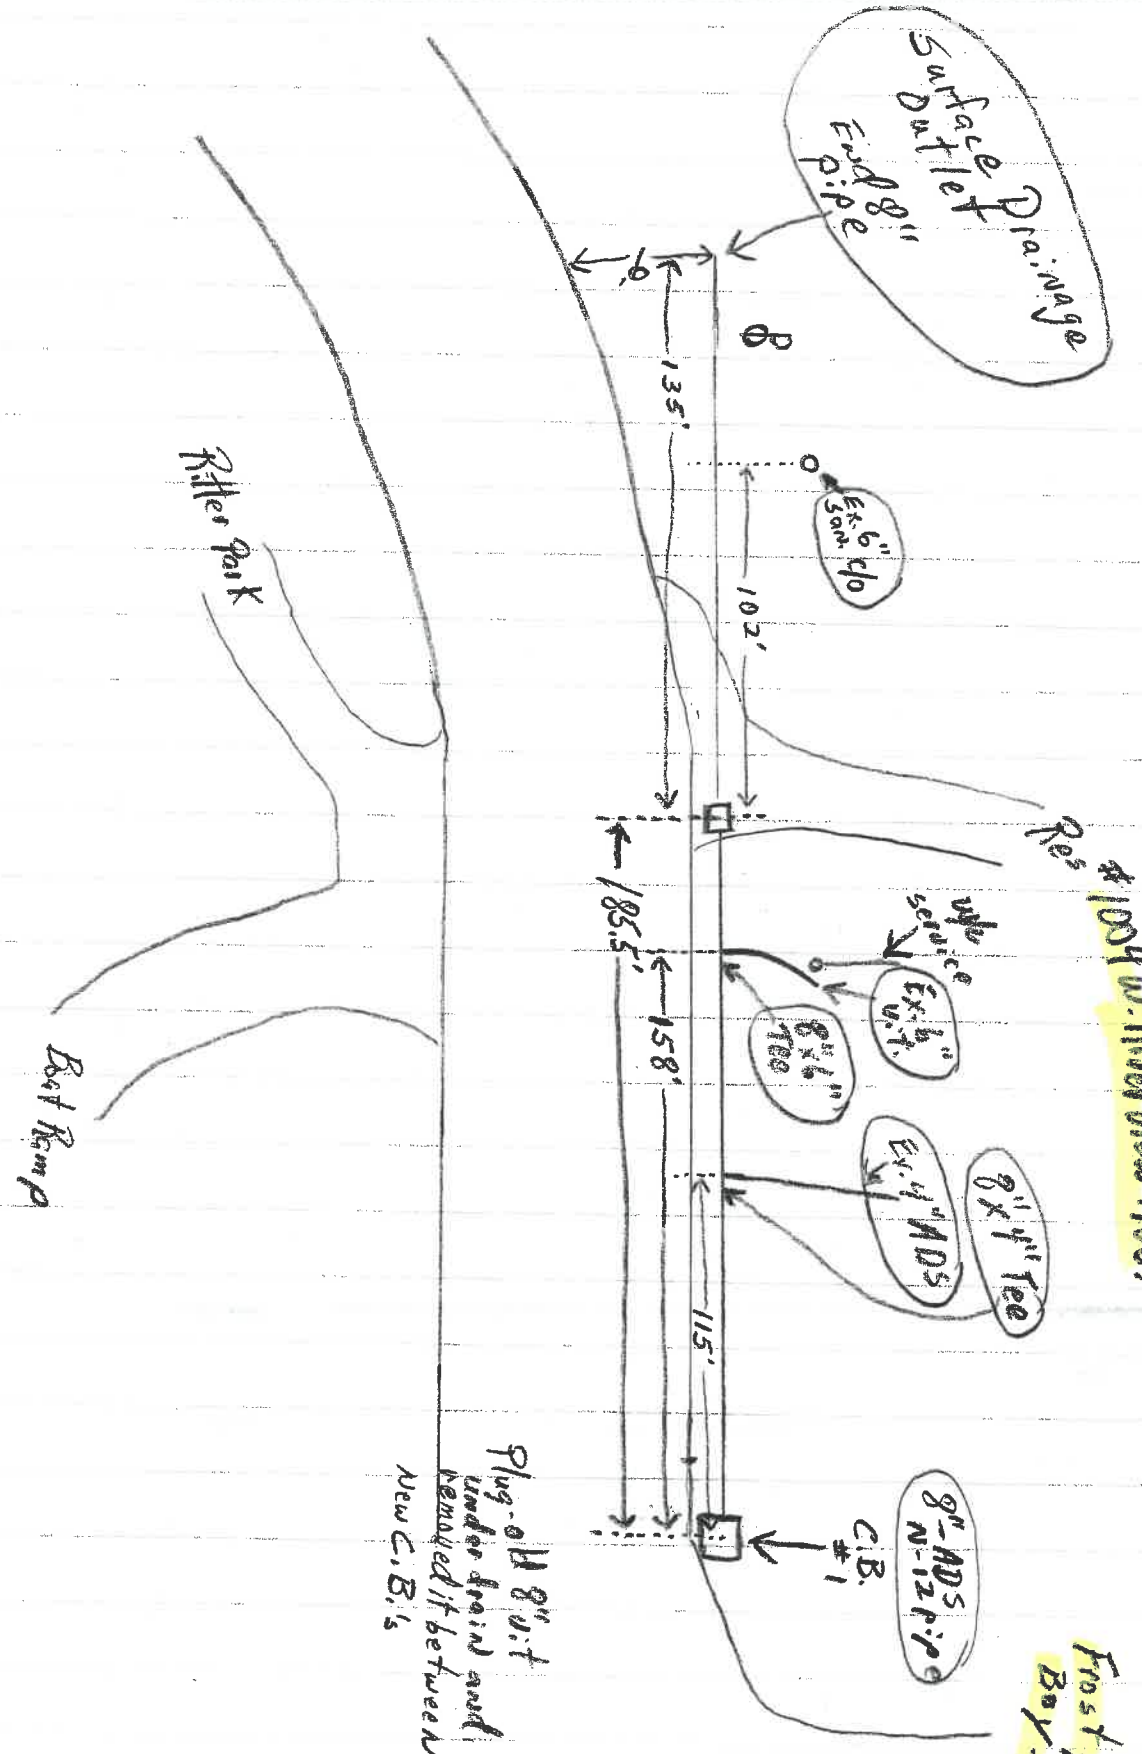
7' off back of bk
where 4" VCP ties
into 8" VCP

Surface Drainage
End 8" Pipe

9" x 1" Tee
Ex. 4" ADS

8" ADS
N-12 pipe
C.B. #1

Plug old 8" unit
under drain and
removed it between
New C.B.'s
