To Miguel Gomez
Fax No. (419) 784-4760
From Adam C. Hoff, P.E. - City Engineer *ACH*
Date 9/9/99
Subject 1059 Scott Street Sanitary Service Connection
Pages 2, including this one

Per our previous telephone conversation, while performing investigation and repair to a City sewer located behind your property at 1059 Scott Street, it was found that a blockage exists in the four (4) inch vitrified clay service connection leading to the City's sewer. As near as we can tell, a major blockage or collapsed tile exists roughly six (6) feet from the existing sanitary clean out. From our experience with vitrified clay service connections and the amount of trees along the route to the City's sewer, it is likely that roots have also intruded into the service connection creating additional, smaller obstructions.

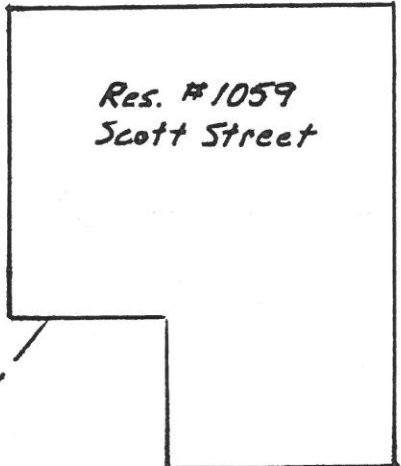
Res. #1059
Scott Street

Existing Cleanout

Broken or Collapsed
Pipe

Ex. 4" Vit. Clay
Service Connection

100' ±

New Wye & 10L.F.
PVC Service Connection

When performing our necessary repairs, the City replaced a short segment of your service connection immediately adjacent to the City's sewer. However, we are confident that additional segments will need to be replaced and/or augered out to allow flows from the residence to discharge to the City sewer. If these obstructions are not addressed, we believe that the sewage will discharge out of the existing clean out onto the lawn and, ultimately, into the Oberhaus Creek creating obvious health concerns. Therefore, it is our recommendation that the service connection be repaired as soon as possible. The following is a sketch showing the approximate locations of each of the above described items.

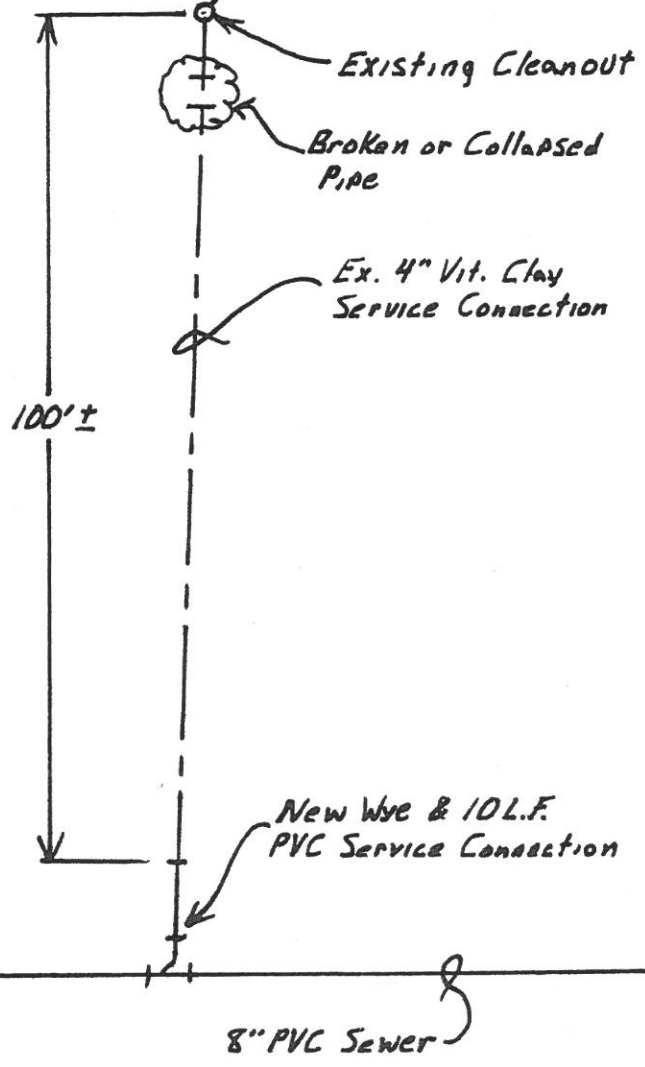
8" PVC Sewer
