CAR-WASH  
North Napoleon  
September 1973

SEWER LINE

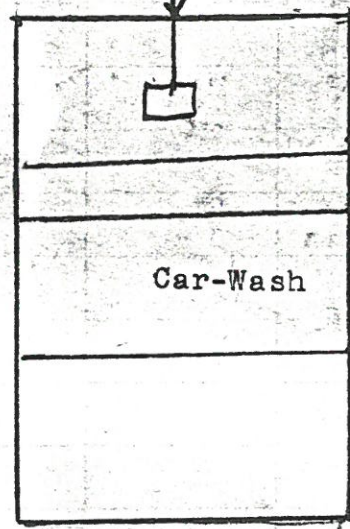
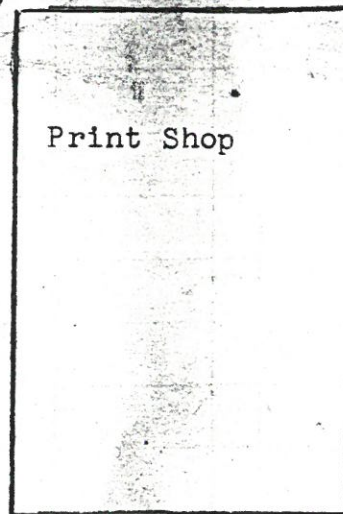
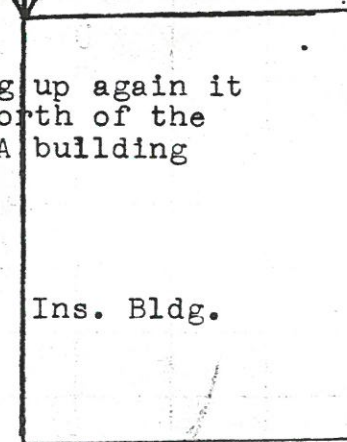
At this point 24 1/2' north of east side of Print Shop and about 120' from manhole at Street curb we dug down to sewer and a broken tile and full of sand on side toward the street after opening the tile on the street side of break with small hose then flushing with fire engine hose this opened up the sewer but the tile remained 3/4 full of water at this point, indicating a dip in the sewer between this point and the street

After flushing was completed sewer remained 1/2 full of water here

At this man hole sewer is clean and ### water flowing freely.

At this point the sewer is clean and water flowing freely.

If sewer is dug up again it should be due north of the west side of AIA building about 41 1/2'.
