9-9-81

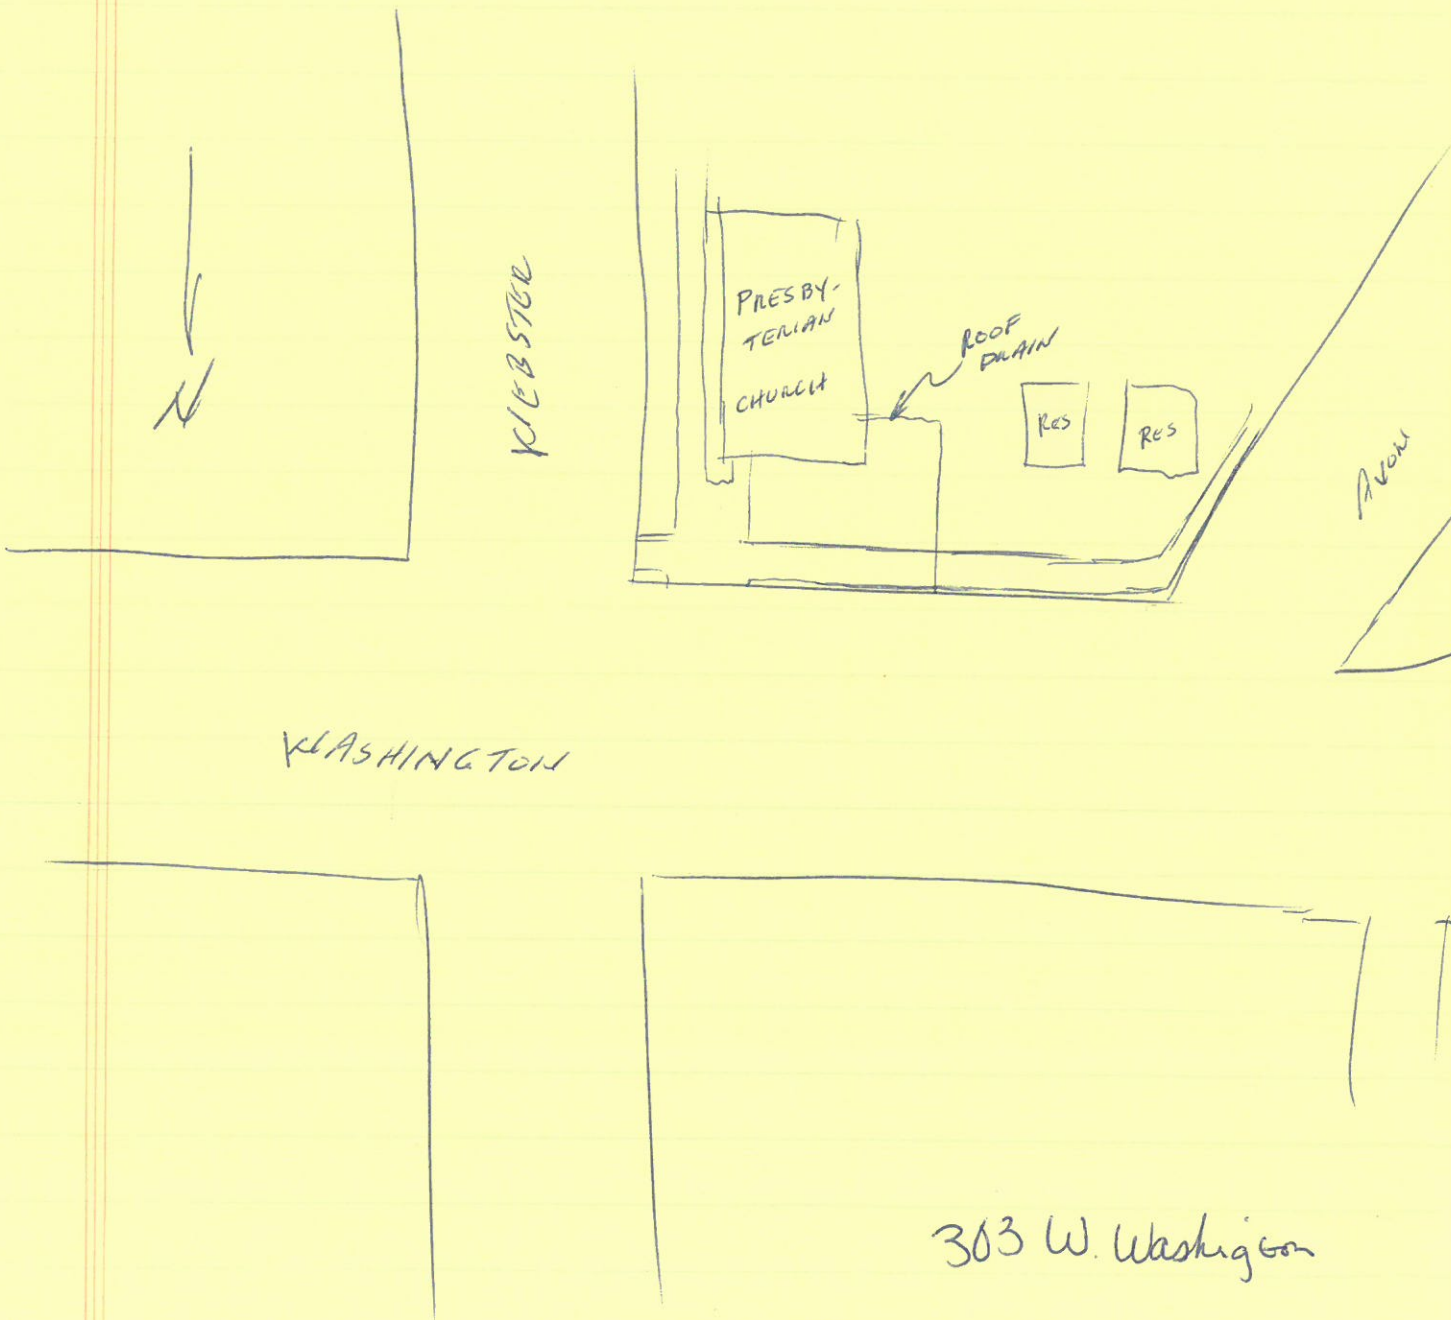
ROOF DRAIN OF CHURCH GOES INTO A TILE TO MIDDLE OF WEST YARD, TURNS NORTH AND TRAVELS UNDER SIDEWALK THROUGH CURB, DUMPS ONTO STREET. THIS IS AN UNACCEPTABLE DRAINAGE PROCEDURE PUT IN BY THE CHURCH.
